# 붙임1

### 신한은행포항남금융센터

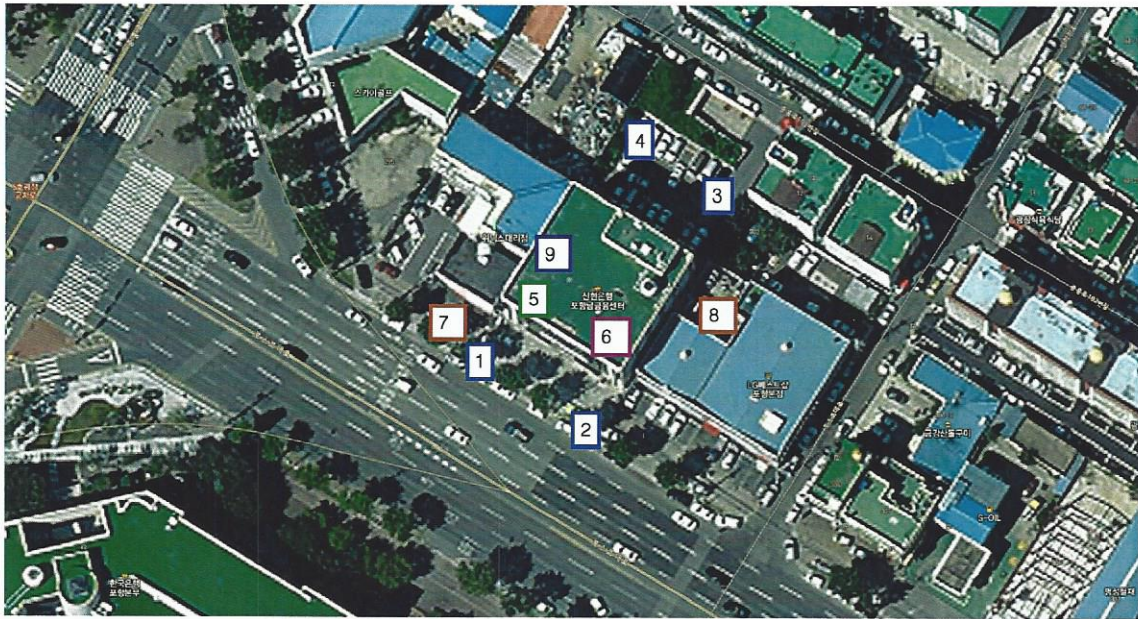
측정 일시	2015. 07. 16. [1~4] 13:00~17:20, [5~9] 14:30~16:30			
측정 결과	시료번호	측정 지점	측정 결과(f/cc)	유량(l/min)
	1	부지경계선1	0.000	10.2
	2	부지경계선2	0.000	10.1
	3	부지경계선3	0.001	10.2
	4	부지경계선4	0.000	10.2
	5	작업장 주변	0.001	10.2
	6	위생설비입구	0.000	10.1
	7	거주자주거지역1	0.000	10.2
	8	거주자주거지역2	0.000	10.2
	9	음압기	0.000	10.2

-   부 지 경 계 선
-   폐기물 보관지점
-   작 업 장 주 변
-   위 생 설 비
-   거주자 주거지역
-   음 압 기

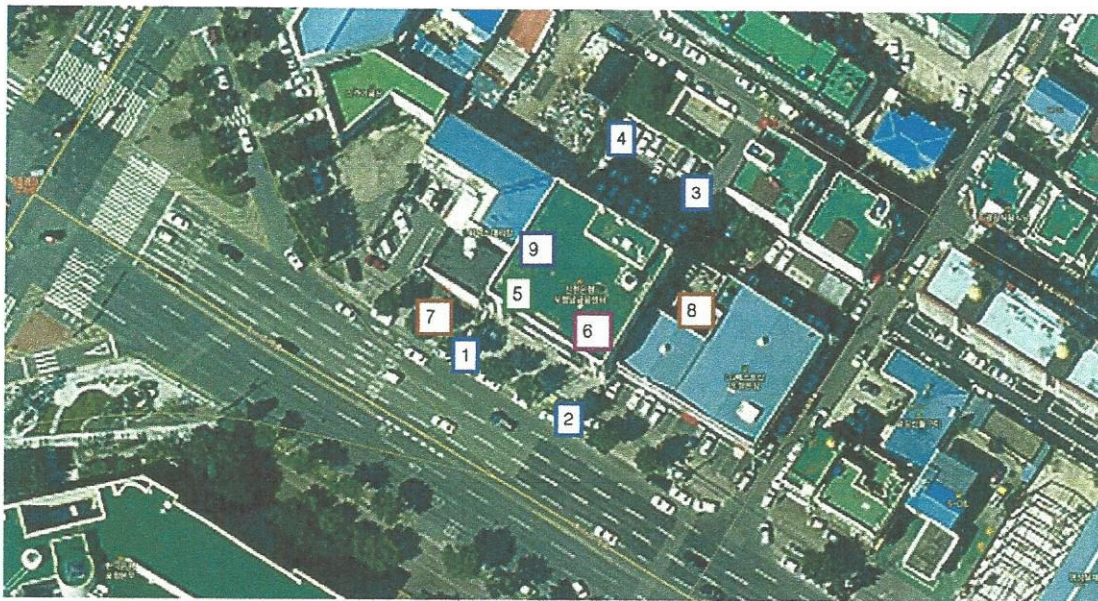
### 신한은행포항남금융센터

측정 일시	2015. 07. 17. [1~4] 09:10~13:20, [5~9] 10:00~12:00			
측정 결과	시료번호	측정 지점	측정 결과(f/cc)	유량(l/min)
	1	부지경계선1	0.000	10.1
	2	부지경계선2	0.000	10.2
	3	부지경계선3	0.000	10.2
	4	부지경계선4	0.000	10.2
	5	작업장 주변	0.002	10.2
	6	위생설비입구	0.000	10.2
	7	거주자주거지역1	0.000	10.2
	8	거주자주거지역2	0.000	10.2
	9	음압기	0.001	10.2

- 부 지 경 계 선
- 폐기물 보관지정
- 작 업 장 주 변
- 위 생 설 비
- 거주자 주거지역
- 음 압 기
