1. 석면비산 측정 결과

2. 석면비산 측정 지점 위치

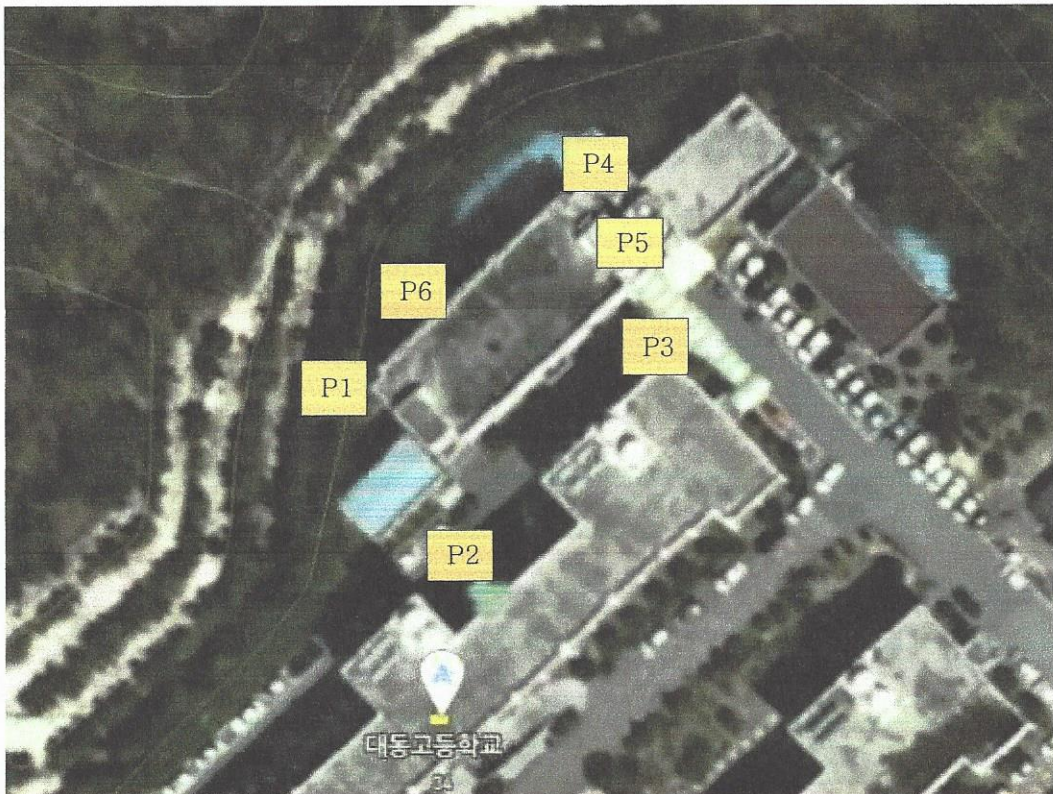
2017.12.14						
측정지점	시료번호	유량(l/min)		시간(분)	측정 결과(f/cc)	검출석면
		분당	총(L)			
부지경계선	P1	10.01	2,402	240	0.000	기준미만
부지경계선	P2	10.02	2,404	240	0.001	기준미만
부지경계선	P3	10.01	2,402	240	0.001	기준미만
부지경계선	P4	10.03	2,407	240	0.000	기준미만
위생설비	P5	10.02	400	40	0.002	기준미만
음압기	P6	10.01	400	40	0.001	기준미만

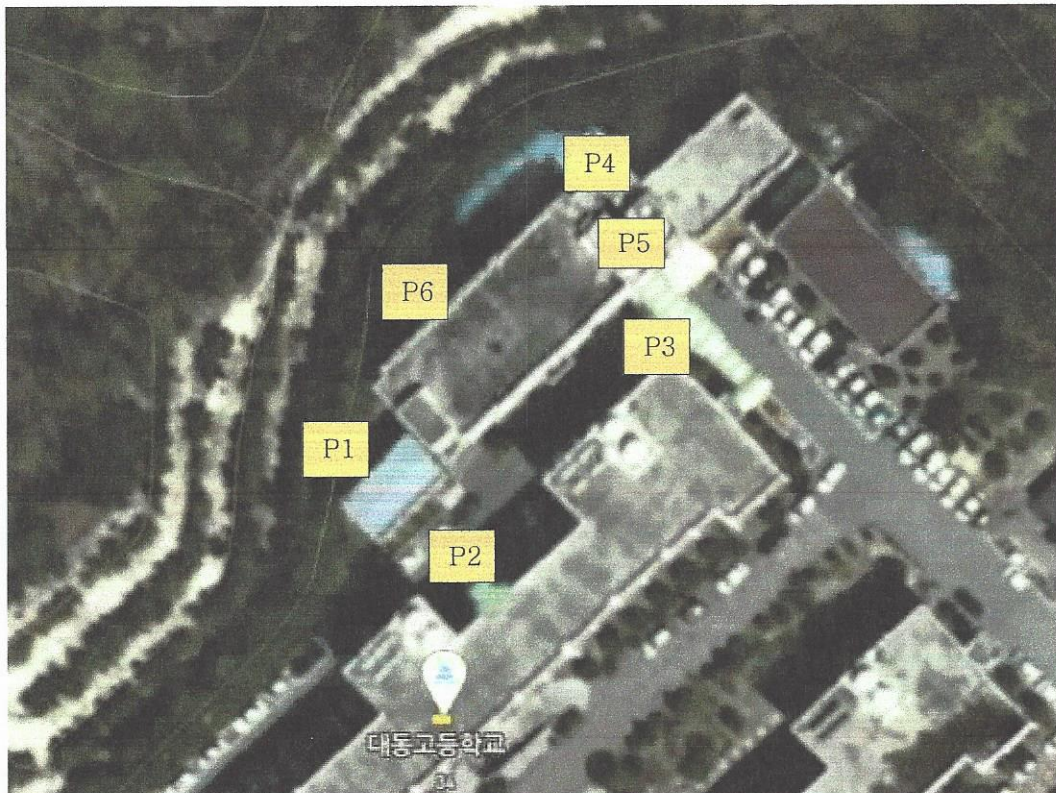
2. 석면비산 측정 지점 위치

2017.12.15						
측정지점	시료번호	유량(l/min)		시간(분)	측정 결과(f/cc)	검출석면
		분당	총(L)			
부지경계선	P1	10.02	2,404	240	0.000	기준미만
부지경계선	P2	10.04	2,409	240	0.000	기준미만
부지경계선	P3	10.03	2,407	240	0.001	기준미만
부지경계선	P4	10.01	2,402	240	0.000	기준미만
위생설비	P5	10.02	400	40	0.001	기준미만
음압기	P6	10.04	401	40	0.001	기준미만

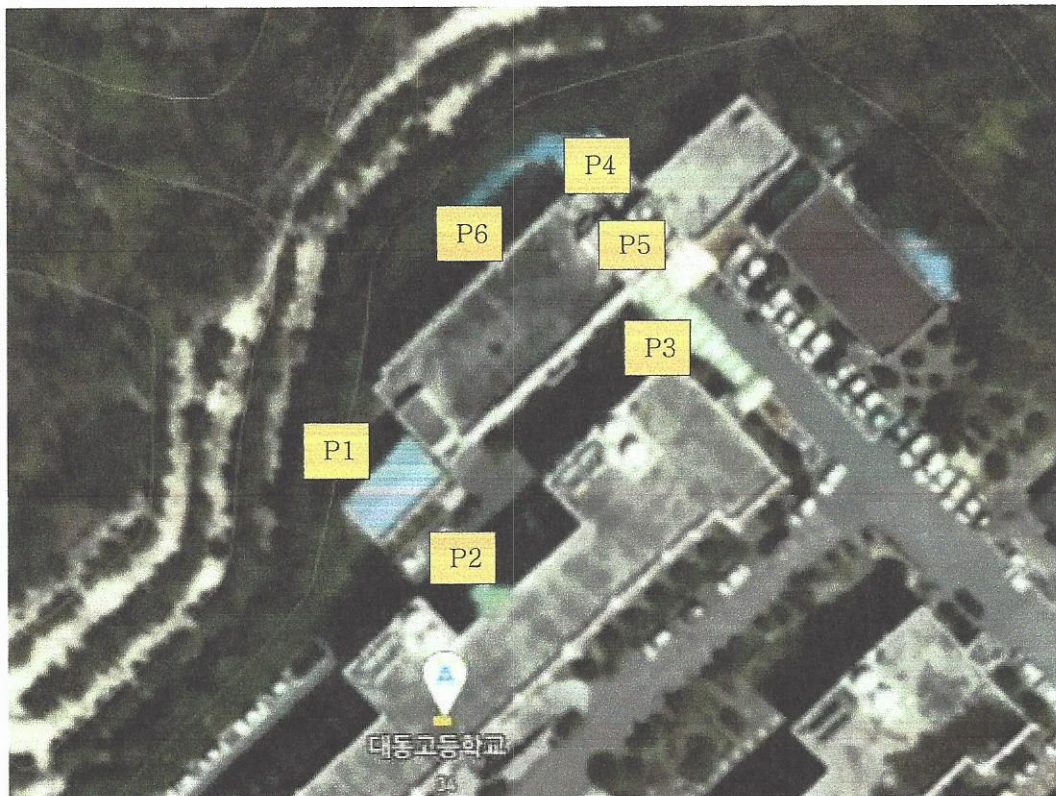
2. 석면비산 측정 지점 위치

2017.12.16						
측정지점	시료번호	유량(l/min)		시간(분)	측정 결과(f/cc)	검출석면
		분당	총(L)			
부지경계선	P1	10.03	2,407	240	0.000	기준미만
부지경계선	P2	10.02	2,404	240	0.001	기준미만
부지경계선	P3	10.03	2,404	240	0.001	기준미만
부지경계선	P4	10.05	2,402	240	0.000	기준미만
위생설비	P5	10.02	400	40	0.002	기준미만
음압기	P6	10.02	400	40	0.001	기준미만

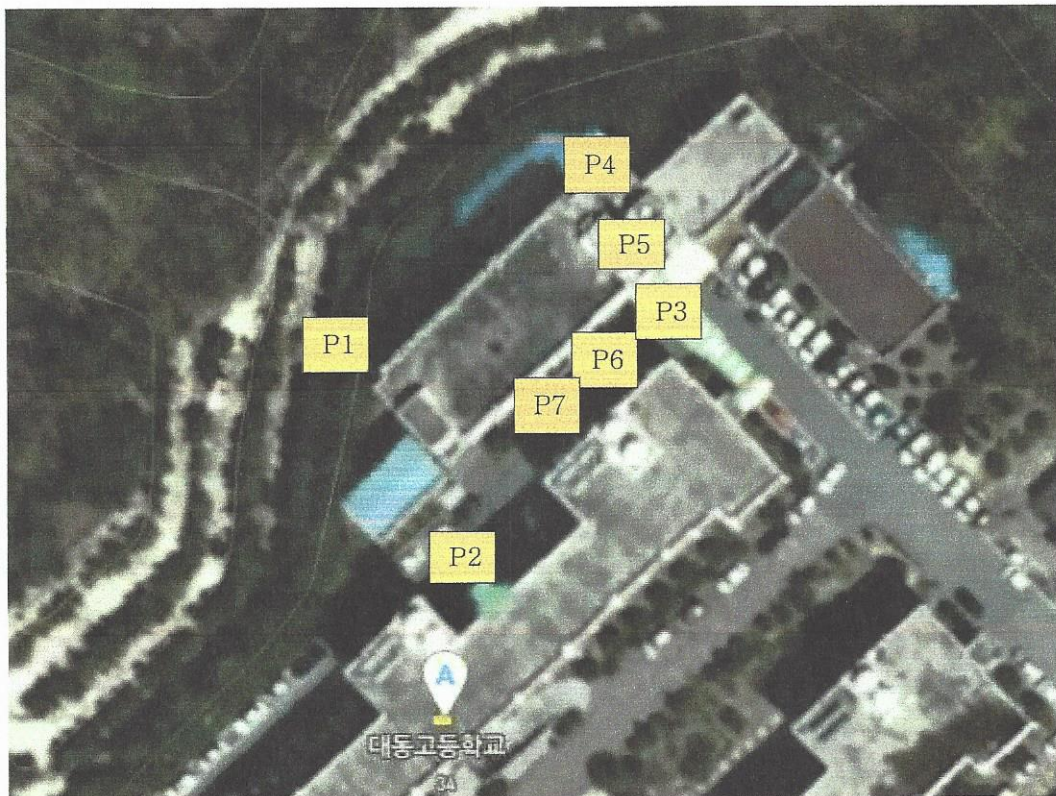
2. 석면비산 측정 지점 위치

2017.12.17						
측정지점	시료번호	유량(l/min)		시간(분)	측정 결과(f/cc)	검출석면
		분당	총(L)			
부지경계선	P1	10.04	2,409	240	0.000	기준미만
부지경계선	P2	10.03	2,407	240	0.002	기준미만
부지경계선	P3	10.01	2,402	240	0.001	기준미만
부지경계선	P4	10.02	2,404	240	0.000	기준미만
위생설비	P5	10.02	400	40	0.000	기준미만
음압기	P6	10.04	401	40	0.001	기준미만
폐기물반출구	P7	10.03	401	40	0.002	기준미만
